Technical Bulletin N0700 – Leap Pal Valve Maintenance (Changing or Cleaning the Valve Rotor)

The Leap Pal valve may require maintenance for cleaning or replacing the rotor. This technical bulletin guides you through the fairly easy process of opening the valve, removing and replacing the rotor, and re-sealing the valve.

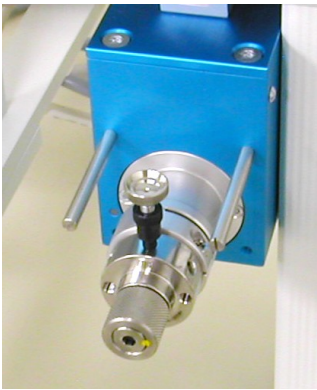
The valve body does not need to be taken off the valve actuator. To clean the valve, simply unscrew the knurled 'pre-load assembly', which is the big, round nut on the front of the valve. You will then have access to the valve rotor for replacement or cleaning. This generally takes only a few minutes.

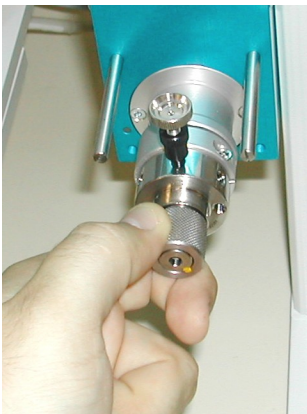
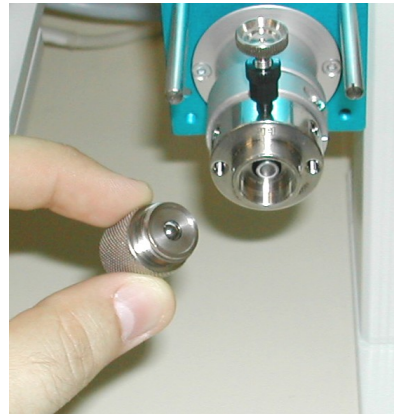
Step 1

Unscrew the knurled preassembly off the front of the valve. This can usually be done by hand. You may want to wear a glove.

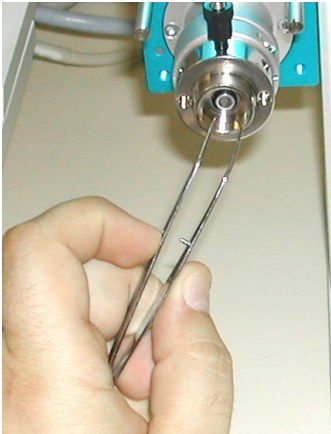
Step 2

Use a clean pair of tweezers to extract the rotor from the valve face. Be careful not to scratch the inside of the valve.

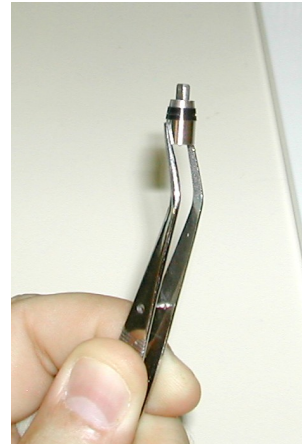
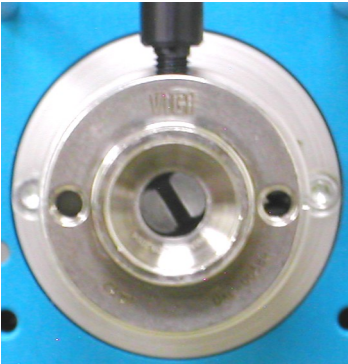
Once the rotor has been extracted, you will be able to see inside the valve to the actuator. (left)

If you examine the rotor (right), you'll see slots in the dark Valcon H material

that act as the channels between the ports; as the rotor is thrown back and forth by the valve actuator, the different ports are connected. These slots can become dirty or blocked and may sometimes require only a simple cleaning. However, the rotor should be examined for excessive wear and if found, it should be replaced (part numbers above).

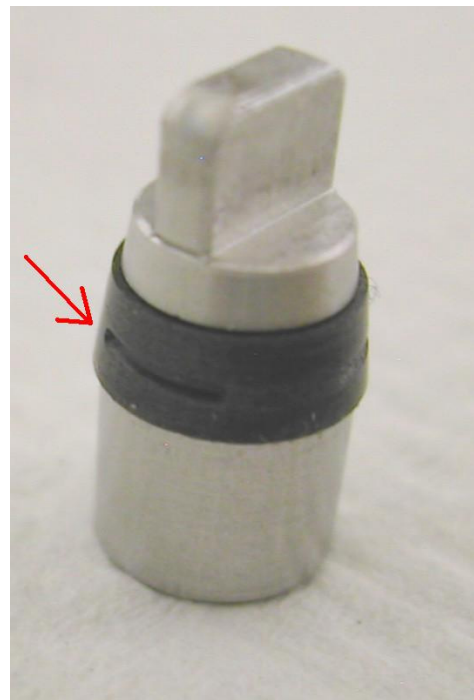
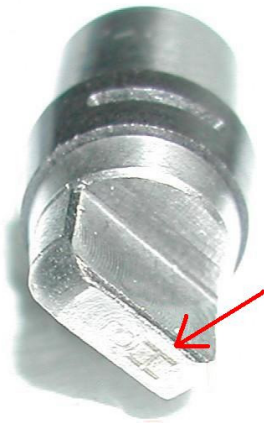
Once the rotor has been cleaned or replaced, begin by examining the back of the rotor. A small H appears on one side of the lip. This letter indicates that the material is Valcon H, a Teflon polymer. When inserting the rotor back into the valve head, this H must be oriented so the H is on the bottom half of the valve. If inserted upside-down, the valve will not work correctly.

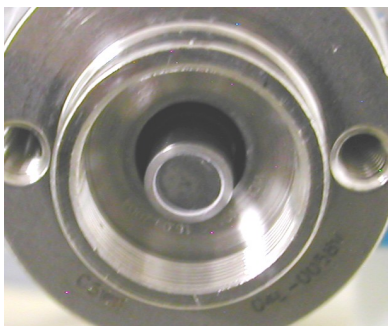
INCORRECT (Protruding)

When reinstalling the rotor, the rotor should be flush with the inside rim of the valve. On the left, the rotor flag is not aligned with the actuator while the valve on the right is perfect.

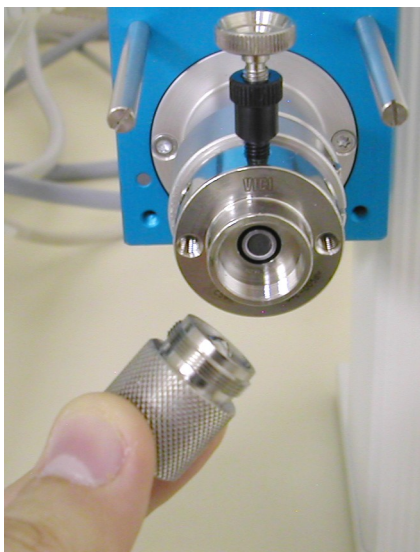
Step 4

Make sure the rotor is still flush with the valve before reattaching the knurled pre-assembly. Place the pre-assembly into the face of the valve and screw in. There will be a moment when the resistance greatly increases. (Bottom left) At this point, the valve is still not tight. Twist the valve several more times until it hits a hard stop and cannot be turned anymore. (Bottom right)

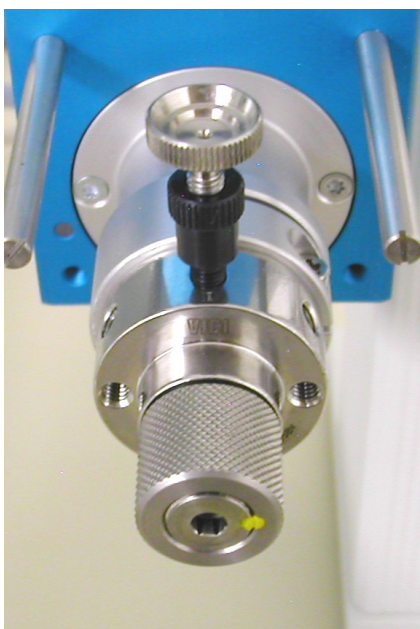
The Leap Pal valve should now be ready for use (left). It is recommended that your solvent of choice be flushed through each port as an initial wash of the rotor to rinse away any manufacturing debris or residue.
